## Router Lift Test Report

09/05/2022

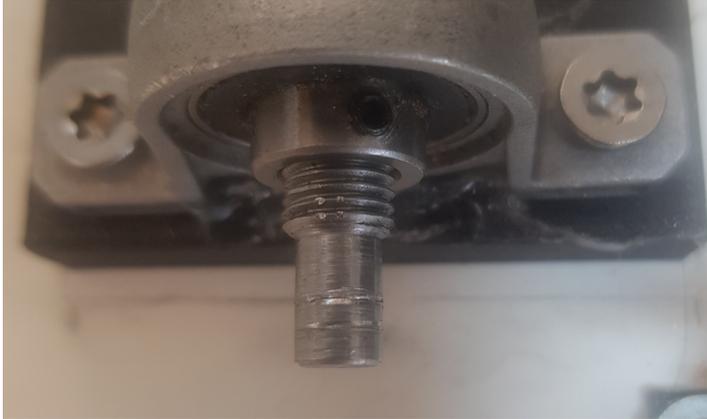
### Grub screw bored channel into lead screw

- Any slippage of the pulley wheel caused the grub screw to dig a groove into the coupling shaft of the lead screw
- This caused the pulley wheel to be locked onto the lead screw

- Use a dremel to remove a small amount of material from the lead screw coupling shaft to allow for pulley wheel change to be easier
- Drilling of seating position hole for grub screw to ensure this doesn't reoccur

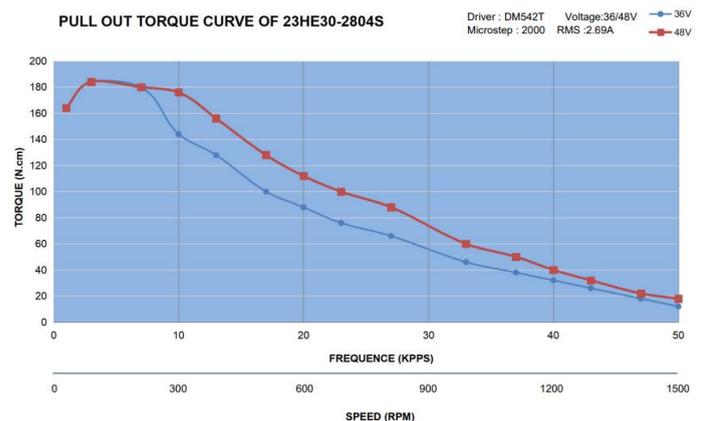
### Higher than 112.5 rpm motor fails to lift load

- This is to be expected, based on *Variable\_Calculator.ipynb*, the lifting torque required is 0.322 NM or 32.3 Ncm
- Based on the Torque curves for the 23HE30-2804S Nema 23 stepper motor, at around 112.5RPM, the torque is around 180 Ncm so this should not be a problem for the Nema

- Try an alternative nema 23 to see if it is a unit failure
- Increase voltage input to 36V to see if this will improve lift at higher RPM
- Cap RPM to 112.5 until new Nema is ordered (conduct reliability testing to ensure this RPM is consistent in lift performance)
