Router Lift Test Report

09/06/2022

Endurance test of the Nema 23 stepper motor whilst lifting and lowering a weight of 10kg and using a trapezoidal spindle with a 3mm thread

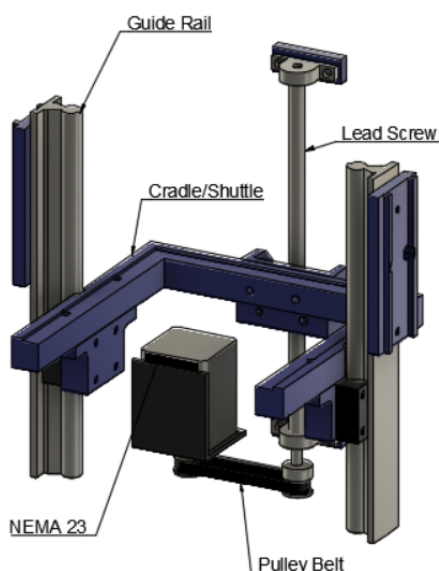
- Loose connection between nut housing and cradle
- Grinding of nut material (brass shavings being shed from nut)
- Cradle wobble
- Loose lower screw bearing

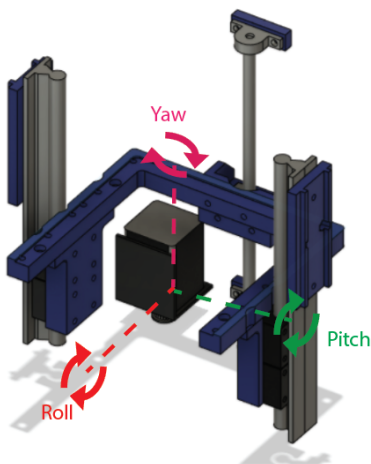
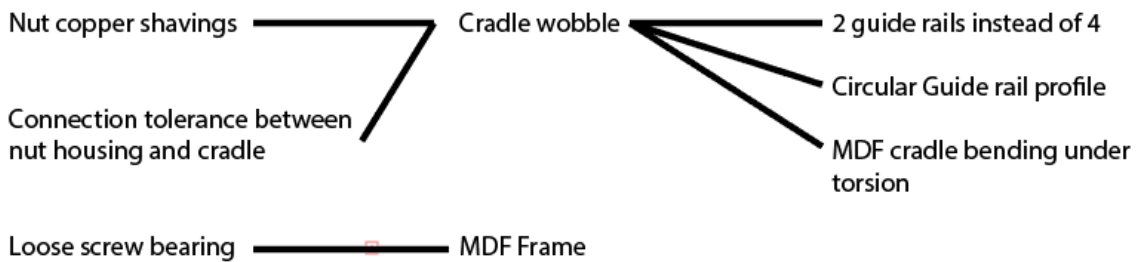
Pitch-Yaw-Roll diagram for reference of rotation axes when discussing cradle wobble

A number of problems are pointed towards cradle wobble, oscillating roll rotation of the cradle is most likely a driver of wear on the nut causing material to be shaved off, furthermore, the loose connection between the nut housing and the cradle may be due to the fact that this wobble (oscillation) may be loosening the screws over time.

There are still a number of solutions that may combat this wobble, firstly, increasing guide rails on either side of the cradle may provide more support and restrict rotation in transit, reducing roll.

The circular profile of the guide rail may also allow for some yaw rotation, so a flat profile guide (like a [BR12 flat rail](#)) may provide a more stable transit for the cradle

Finally, the cradle material itself may be the cause of this wobble. MDF may be bending causing the axis of each arm to cyclically not be parallel with the axis of the guide rail. By using a more rigid material, such as milled aluminium. This wobble problem may be resolved.
