## Router Lift Test Report

09/05/2022

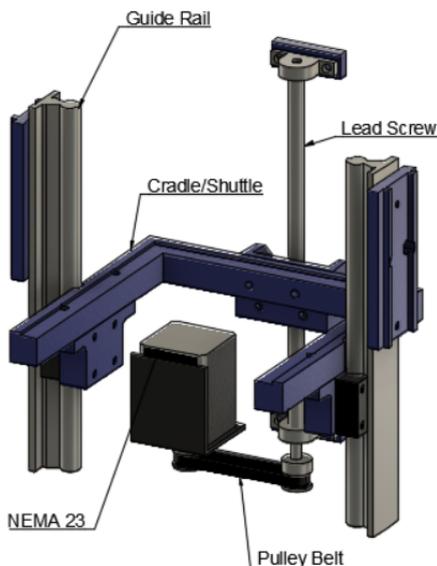
Test	Pass/Fail	Notes
Range of motion test	Pass	At all speeds and a <b>2:1</b> and <b>1:1</b> belt ratio, the lift exhibited full range of motion and could reach repeatable positions Cradle exhibited asymmetrical rising, one side would raise then the other would lag behind/
2.5KG lift test	Pass	At lower speeds on <b>2:1</b> ratio and mid range speeds at <b>1:1</b> ratio, cradle could lift <b>2.5kg</b> of mass (with asymmetrical rising)
5 KG lift test	Pass	At lower speeds on <b>2:1</b> ratio and mid range speeds at <b>1:1</b> ratio, cradle could lift <b>5kg</b> of mass (with asymmetrical rising)
7.5 KG lift test	Pass	At lower speeds speeds at <b>1:1</b> ratio, cradle could lift <b>7.5kg</b> of mass (with asymmetrical rising)
10 KG lift test	Pass	At <b>112.5 RPM</b> at <b>1:1</b> a <b>10 kg</b> load can be fully raised and lowered without incidence
